LINDSTRAND TECHNOLOGIES LTD

HOT AIR BALLOON MAINTENANCE MANUAL

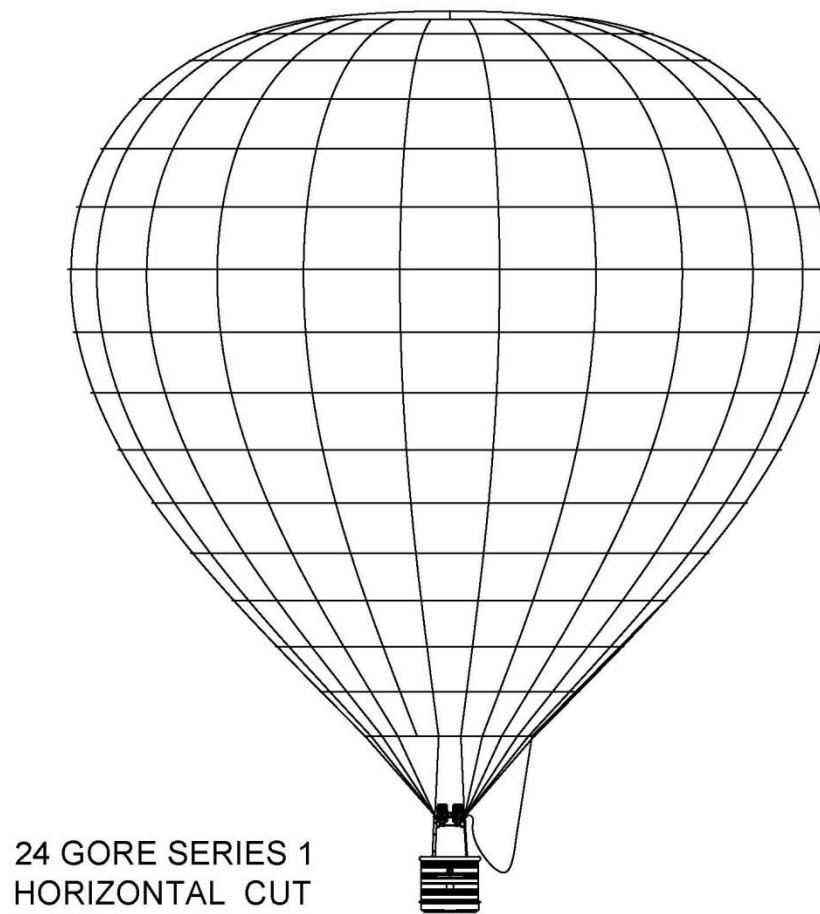
Figure 1 - Series 1, 24 Gore Envelope

The Series 1 and Racer range are smooth 24 gore envelopes. There are several models in the Series 1 range from 70,000 cubic ft (1,982 cu.m) to 180,000 cubic ft (5,100 cu.m). See Figure 1 (Appendix C) for a typical Series 1 envelope.

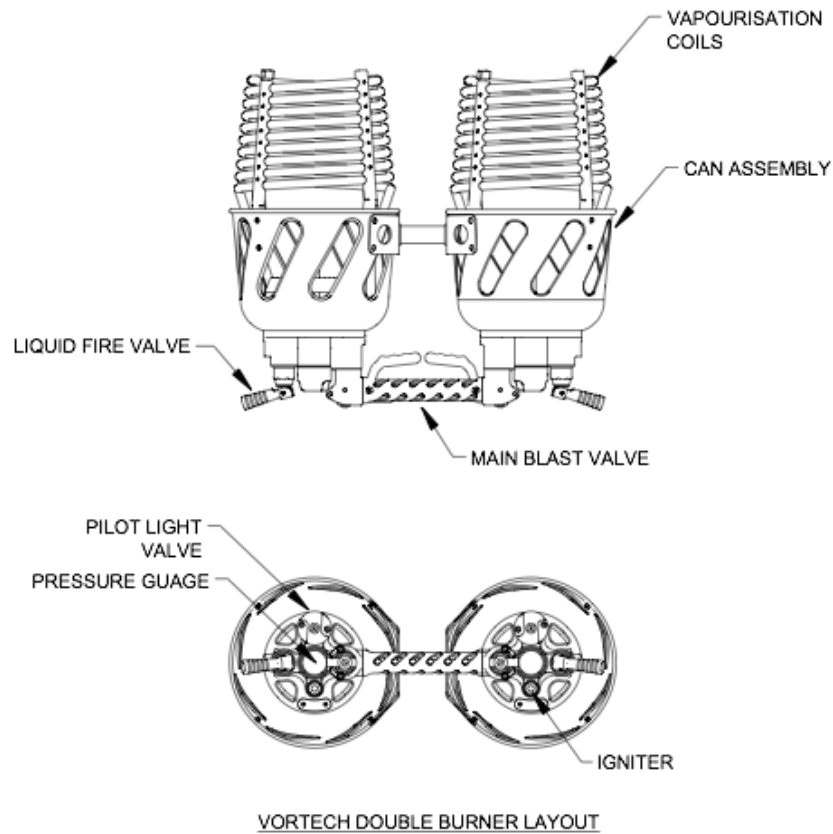
Figure 2 - Overview of Vortech Double Burner

For description see Figure 2, Appendix C.

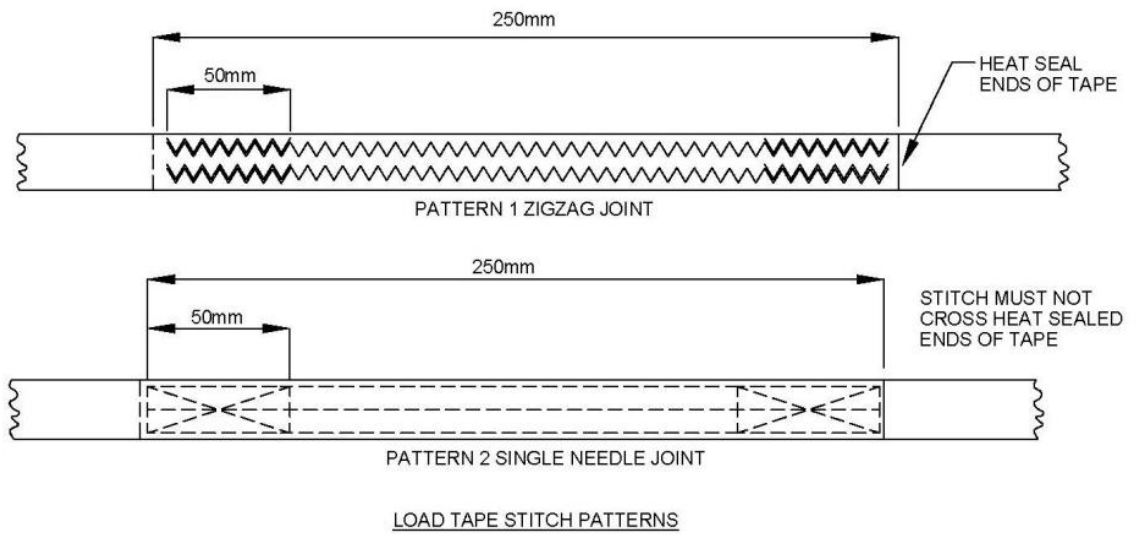
Figure 3 - Load Tape Repairs

If load tape is damaged it should be repaired by splicing a new section of load tape to replace the damaged section. The load tapes should be unpicked to approximately 300 mm beyond each end of the damaged section. A new section totally 500 mm longer than the damaged section should then be stitched with a 250 mm overlap of each of the damaged end. The load tape should be spliced before reattached to the envelope. For diagram see Figure 3, Appendix C.

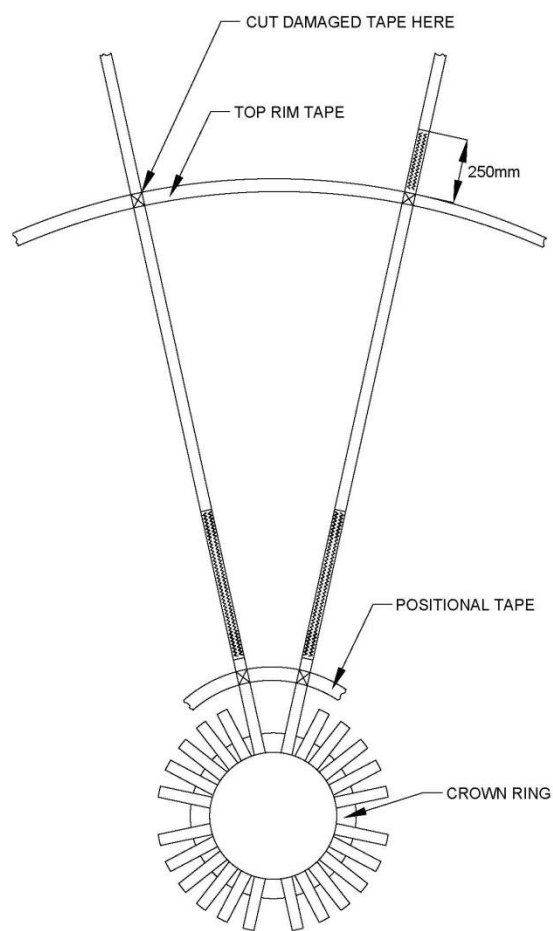
Figure 4 - Overlying Tape Repairs

For diagram see Figure 4, Appendix C.

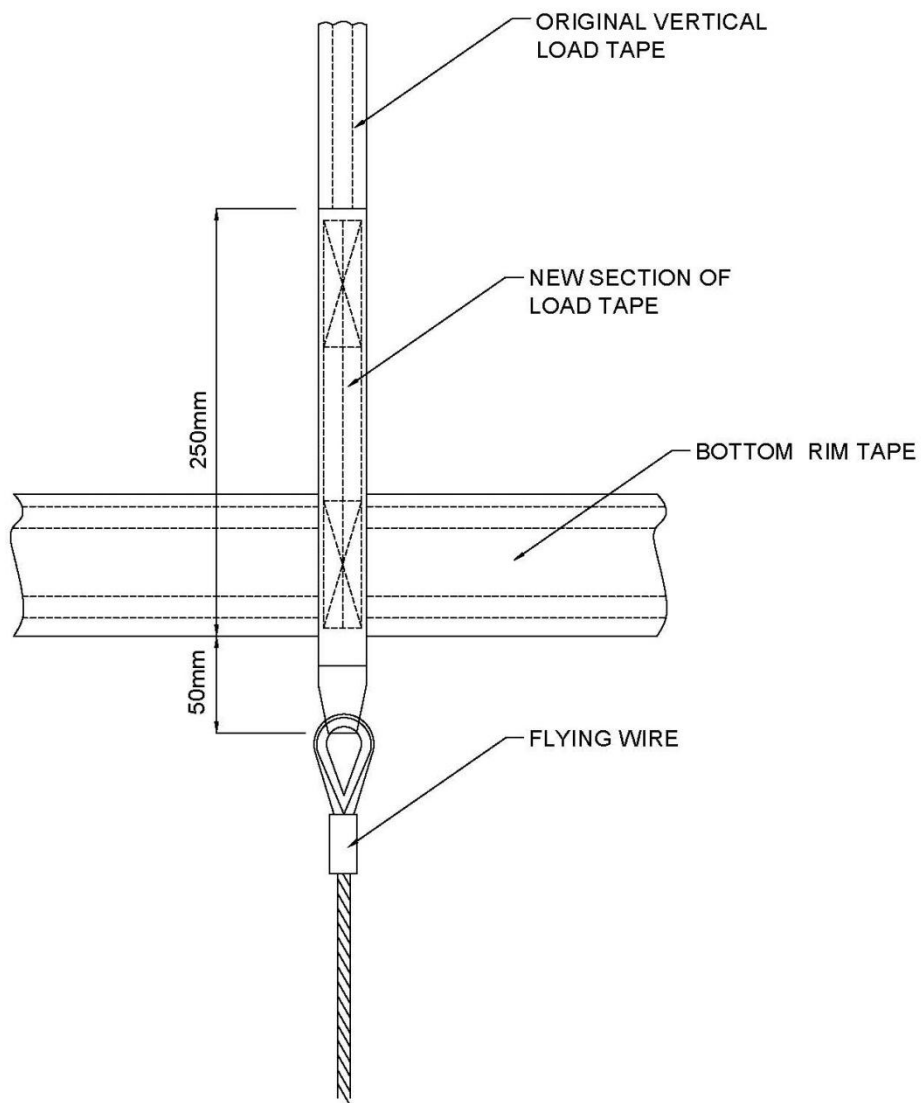
Figure 5 - Envelope Cable Loop Repairs

For diagram see Figure 5, Appendix C.

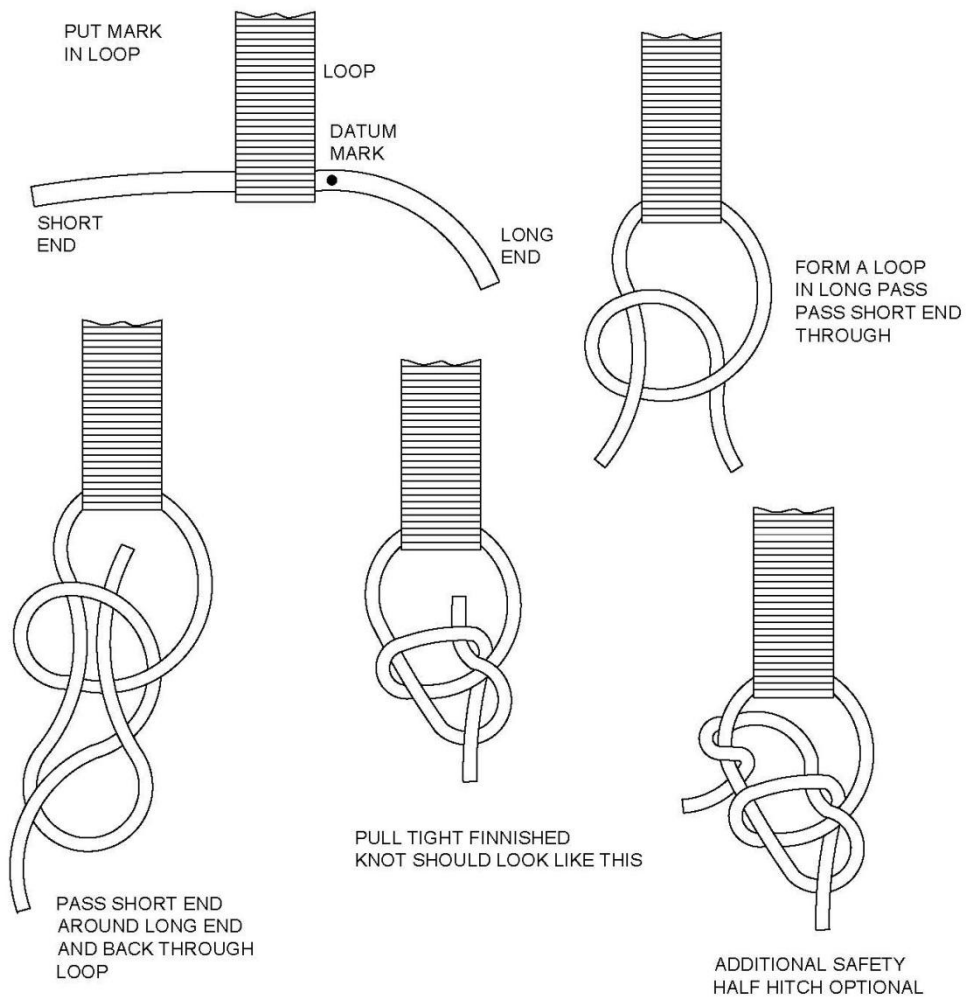
Figure 6 - Overhand Loop Knot

Cut the Kevlar cords and tie an overhand knot at the end to prevent fraying. When refitting the cords, note which mark is aligned with the loop on the parachute and on the envelope. Hold the correct mark in place and secure the line by tying an overhand loop knot as shown in Figure 6, in Appendix C. Once complete, check the parachute positioning by pulling the vertical tape very tight between the parachute opening and the centralising line attachment point. While the vertical tape is held tightly, pull the parachute toward the crown ring until all slack is out of the centralising line. Do not stretch the line. There should be 25 cm of overlap of parachute inside the envelope. The envelope should be test inflated and position of parachute checked for correct fitting and operation.
